Troubleshooting the Beacon

The Beacon in Pivot Irrigation Systems

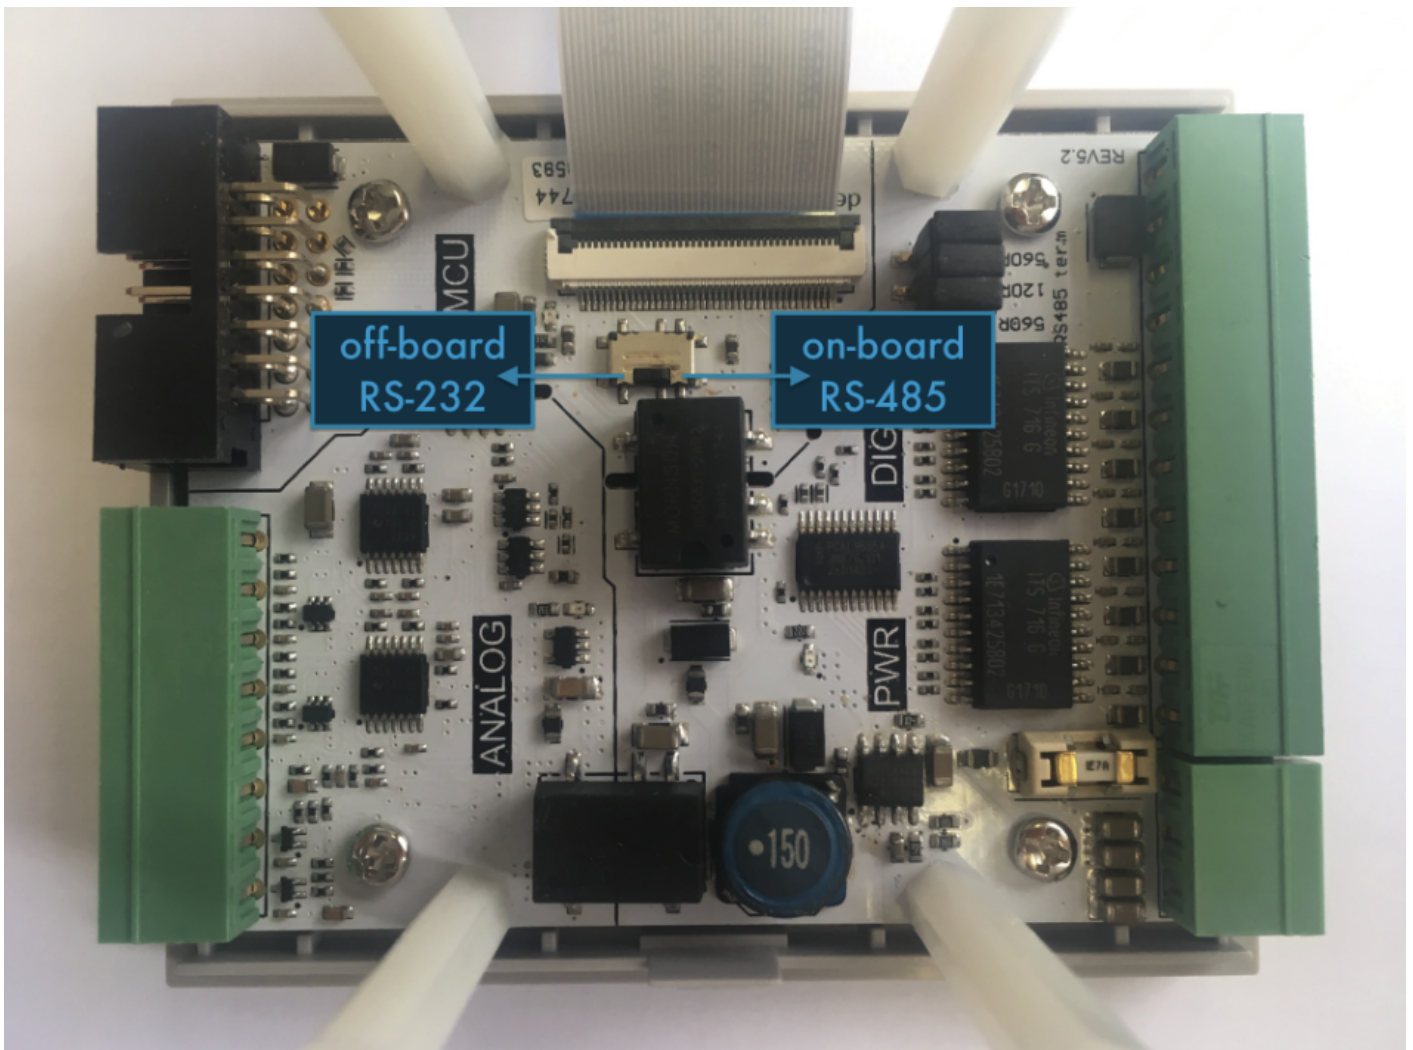
"Message without payload" - The beacon does not send any data via the serial connection

It could be that the internal physical switch is not set correctly. The switch is located inside the Beacon.

The switch should be **set towards the 14-pin connector** to enable serial communication via **RS-232**.
